UNITED STATES ENVIRONMENTAL PROTECTION AGENCY

**RE: Request for Information (“RFI”) Pursuant to Section 308 of the Clean Water Act
Docket No. CWA-IR-16-005
A. Messina & Sons Properties, LLC – 19 Orchard Drive Facility (NYU008129)
Compliance Evaluation Inspection conducted on September 29, 2015**

COMPLIANCE EVALUATION INSPECTION REPORT

Compliance Evaluation Inspection: A. Messina & Sons Properties, LLC	
Inspection Date: September 29, 2015	EPA Inspector: Kimberly McEathron, Physical Scientist, USEPA Region 2, (212) 637-4228
Inspection Time: 8:30 AM – 10:30 AM	
On-Site Representative: Anthony Messina, Co-Owner, A. Messina & Sons Properties, LLC, (845) 883-6543	
Site Information: Lat / Long: 41.653037, -74.115302 A. Messina & Sons Properties, LLC 19 Orchard Drive Gardiner, NY 12588 SPDES/ICIS No. NYU008129	
SIC Code: 5093 – Scrap and Waste Materials

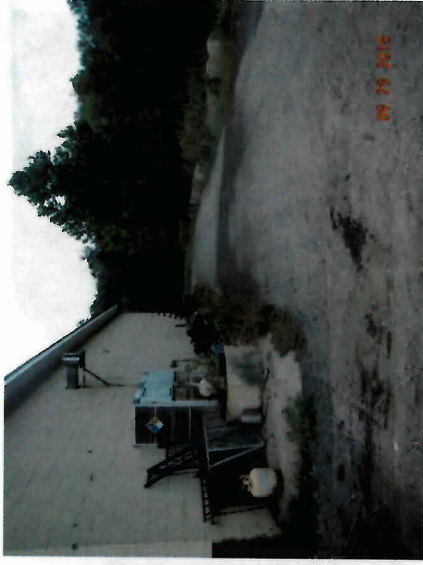
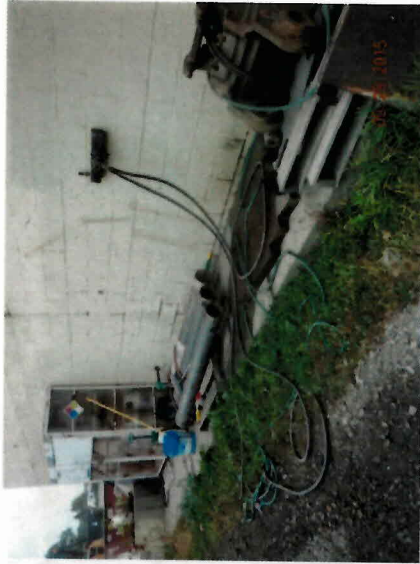
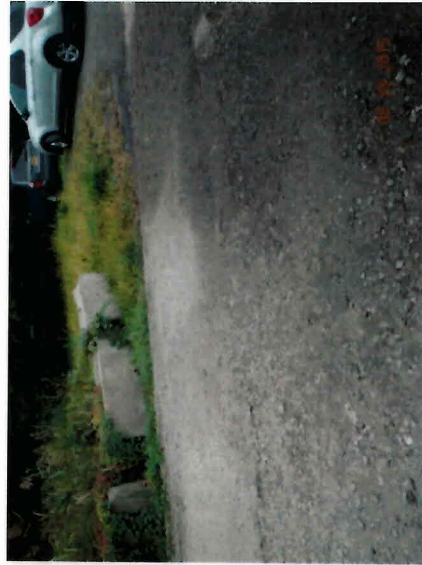
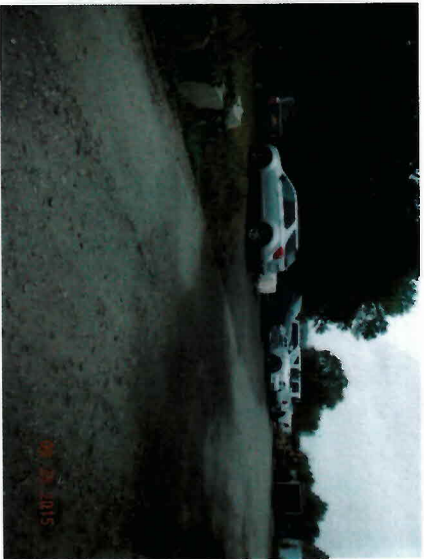
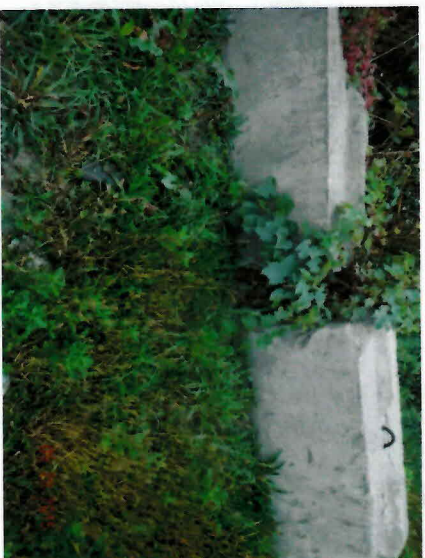
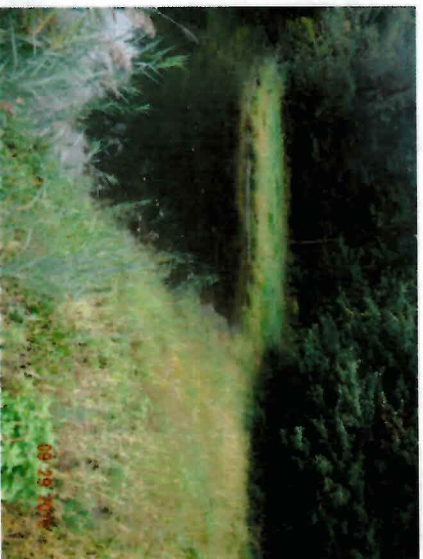
At the time of the inspection, EPA inspector McEathron observed that the ground was wet extending from the south wall of the maintenance garage to the pond with a hose, spray canister and detergent located in this area (see photographs DSCN5326.JPG – DSCN5331.JPG). According to the on-site representatives, vehicles and equipment are hosed off at this location to remove dirt and personal vehicles have been washed at this location using detergent. At the time of the inspection, the on-site representative stated that the vehicle rinsing and washing activities at this location will cease immediately, however, this has not been confirmed or certified in writing.

3. According to the on-site representatives, vehicles and equipment are hosed off adjacent to the pond to remove dirt and personal vehicles have been washed at this location using detergent; and

1. Within seven (7) calendar days of receipt of this RFI, A. Messina shall submit to EPA a signed written statement certifying that A. Messina has permanently ceased on-site vehicle and equipment washing and rinsing activities that may result in discharges to the pond or wetland on-site;
2. Within thirty (30) calendar days of receipt of this RFI, A. Messina shall submit to EPA a copy of the Construction General Permit Notice of Intent (“NOI”) and associated finalized Stormwater Pollution Prevention Plan (“SWPPP”); and
3. Within sixty (60) calendar days of receipt of this RFI, A. Messina shall submit to EPA a copy of the State Pollutant Discharge Elimination System (“SPDES”) Individual Permit NOI and associated finalized SWPPP.

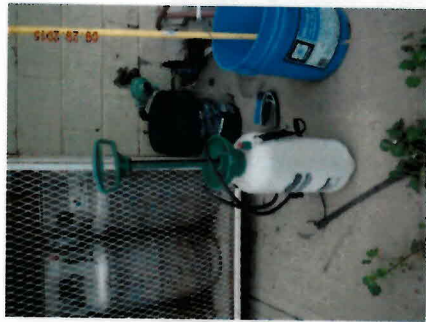
DSCN5333

DSCN5331.JPG	View of the southwest corner of the pond
DSCN5332.JPG	View of the east side of the Pond
DSCN5333.JPG	Detergent in the vehicle wash area adjacent to the pond
DSCN5334.JPG	Storage and processing/sorting and loading area in the center of the Facility
DSCN5335.JPG	Aluminum and steel storage piles in the center of the Facility
DSCN5336.JPG	Dumpsters and 55-gallon drums in the western portion of the Facility
DSCN5337.JPG	Western portion of the Facility (view facing south)
DSCN5338.JPG	Western portion of the Facility (view facing west)
DSCN5339.JPG	Northwest portion of the Facility
DSCN5340.JPG	Northwest portion of the Facility
DSCN5341.JPG	Dumpsters in northwest portion of the Facility
DSCN5342.JPG	View of the sorting portion of the Facility from the west
DSCN5343.JPG	Forested area south of the Facility
DSCN5344.JPG	Forested area west of the pond
DSCN5345.JPG	Southwest corner of the pond
DSCN5346.JPG	Forested area west of the pond

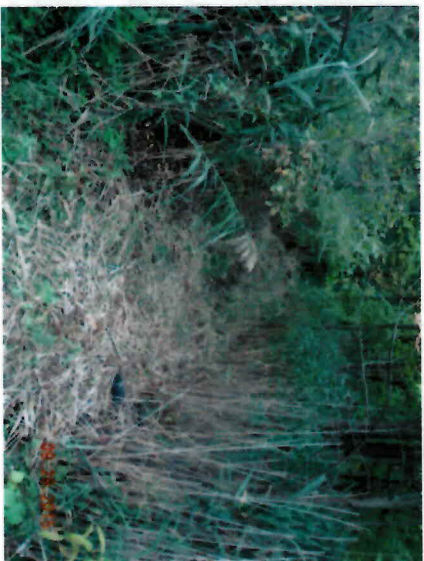
DSCN5347

DSCN5347.JPG	ATV trail into the forested area south of the Facility
DSCN5348.JPG	Forested area south of the Facility
DSCN5349.JPG	Forested area southwest of the Facility
DSCN5350.JPG	Trail west of the Facility heading south
DSCN5351.JPG	Forested area southwest of the Facility
DSCN5352.JPG	Trail west of the Facility heading south
DSCN5353.JPG	End of defined trail south of the Facility heading east
DSCN5354.JPG	East side of Orchard Drive view facing south at Facility driveway
DSCN5355.JPG	Gravel driveway into facility from Orchard Drive
DSCN5356.JPG	East side of Orchard Drive view facing north at Facility driveway
DSCN5357.JPG	Culvert pipe under Orchard Drive near house #58, south of Facility (off-site)
DSCN5358.JPG	Downstream/west side of channel (off-site)
DSCN5359.JPG	Downstream/west side of channel (off-site)
DSCN5360.JPG	Upstream side of channel (off-site)
DSCN5361.JPG	Upstream side of channel (off-site)

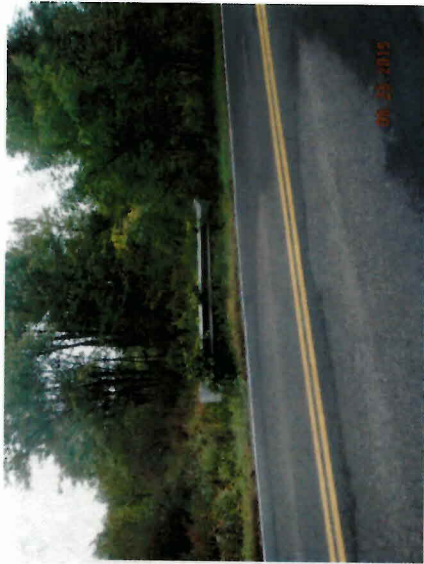
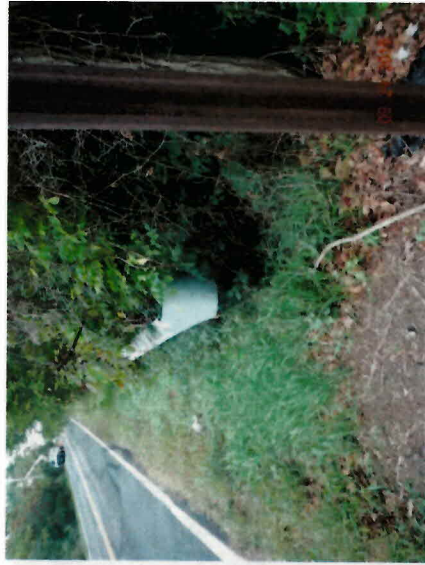
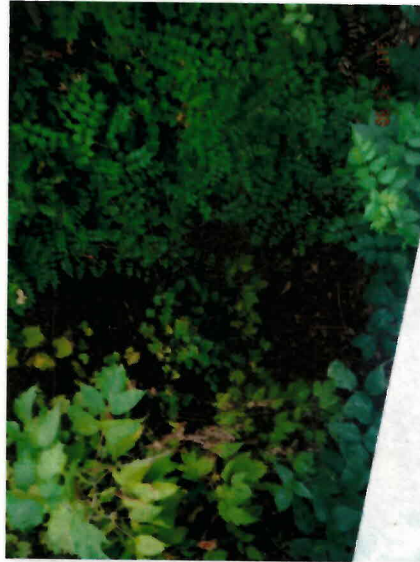
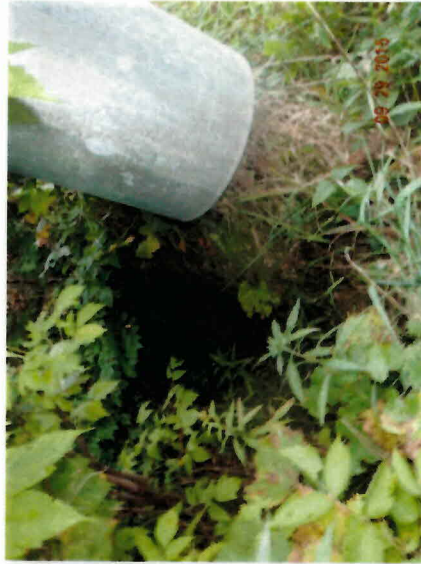
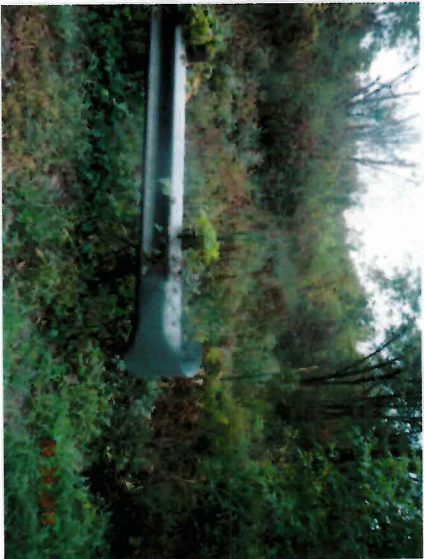
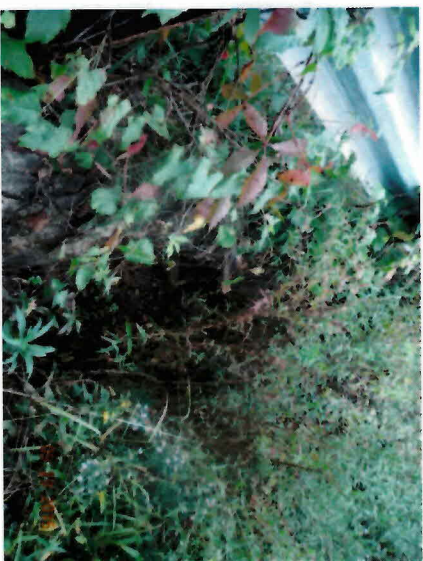
At the time of the inspection, EPA inspector McEathron did not observe catch basins, inlets, drainage swales or ditches on-site or along the driveway or in the immediate area along Orchard Drive (see photographs DSCN5354.JPG – DSCN5356.JPG). EPA inspector McEathron observed a pond on-site located immediately south of the maintenance garage (DSCN5331.JPG – DSCN5332.JPG). At the time of the inspection, EPA inspector McEathron observed stagnant water in the pond and a low point located at the south of the pond where there were areas lacking vegetative growth and appeared to be an overland spillway into a forested wetland (see photographs DSCN5343.JPG – DSCN5345.JPG). Based on observations at the time of the inspection and on-site representatives, there were no piped connections to the pond or wetland on-site. At the time of the inspection, EPA inspector McEathron walked through and along the forested area south of the Site and did not observe standing water in the forested area but did observe phragmites and cat tails (see photographs DSCN5345.JPG – DSCN5349.JPG). According to on-site representatives and topographic maps, the forested area south of the Site is a wetland, NYSDEC Freshwater Wetland CD-23, which extends south and drains to an unnamed tributary. At the time of the inspection, EPA inspector McEathron observed a culvert pipe under Orchard Drive approximately 1,900 feet south of the Facility with a drainage swale extending from the general area south of the wetland and then west approximately 1,000 feet into an unnamed north-flowing tributary to the Wallkill River (see photographs DSCN5357.JPG – DSCN5362.JPG).

2. Stormwater runoff from the Facility flows into a pond on-site which overland flows into NYSDEC Freshwater Wetland CD-23 which then flows to a tributary to the Wallkill River;

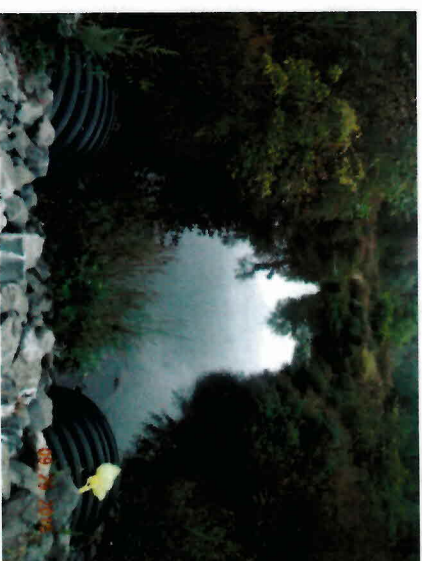
DSCN5364

DSCN5362.JPG	Upstream side of channel (off-site)
DSCN5363.JPG	House #58, south of Facility (off-site)
DSCN5364.JPG	Two pipe culverts and stream under Anderson Road south of Facility (view upstream) (off-site)
DSCN5365.JPG	Two pipe culverts and stream under Anderson Road south of Facility (view upstream) (off-site)
